AllSpec Services
5771 Mining Terrace, Ste 101
Jacksonville, FL 32257
(904) 448-5016
Charles@allspecsolutions.com

Doc#: 10230119

We have enclosed the report for the property inspection we conducted for you on Monday, October 16, 2023 at:

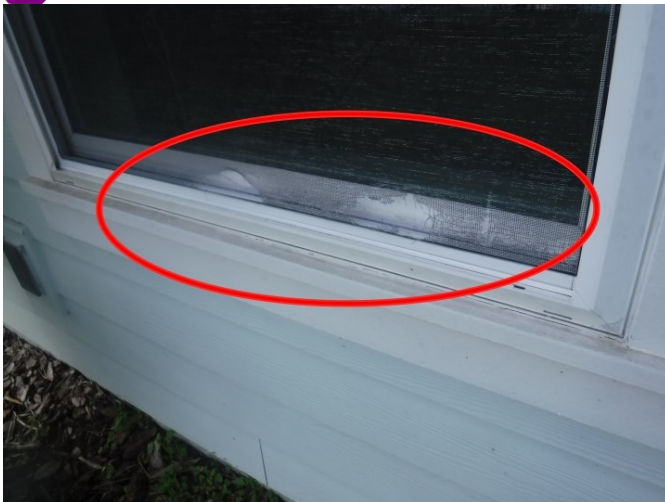
1105. WINDOWS

MIN There is a damaged screens at right rear, suggest corrections for proper use and operation of windows.

MIN 1: There is a damaged screens at right rear, suggest corrections for proper use and operation of windows.

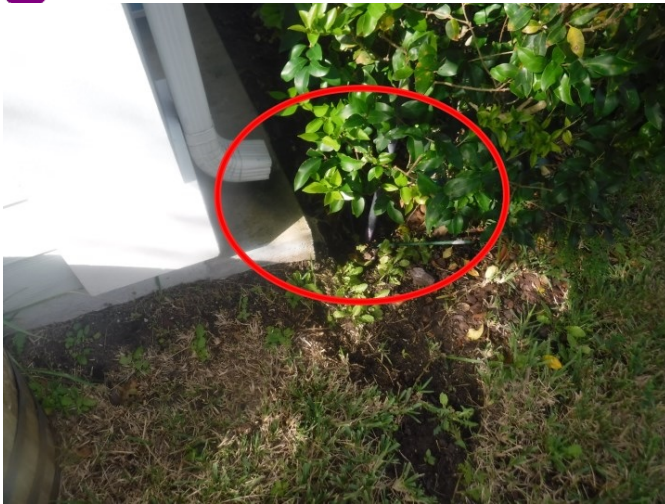
1107. GUTTERS / DOWNSPOUTS

Suggest installing extensions to gutter system at left rear to ensure proper drainage away from foundation.

MIN 2: Suggest installing extensions to gutter system at left rear to ensure proper drainage away from foundation.

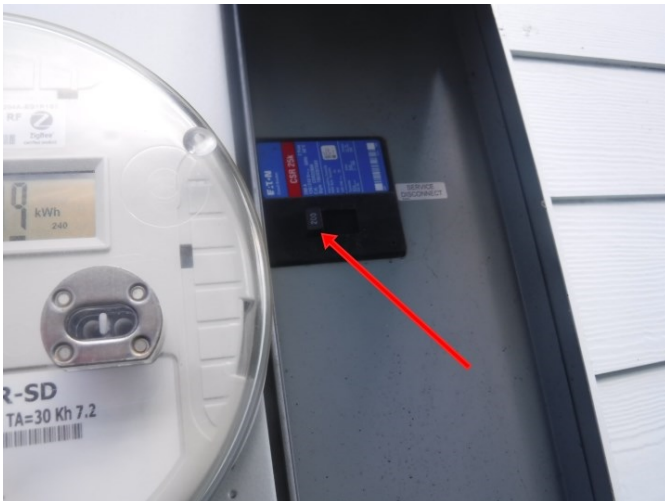
1110. ELECTRIC METER(S)

The electric meter is located at the right side.

Main dis-connect noted at meter

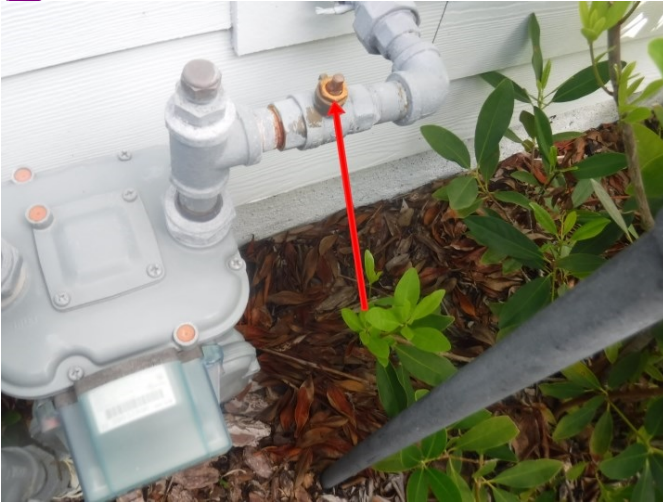
1111. GAS METER(S)

Owners shutoff valve is missing handle. Repair as needed.

MIN 3: Owners shutoff valve is missing handle. Repair as needed.

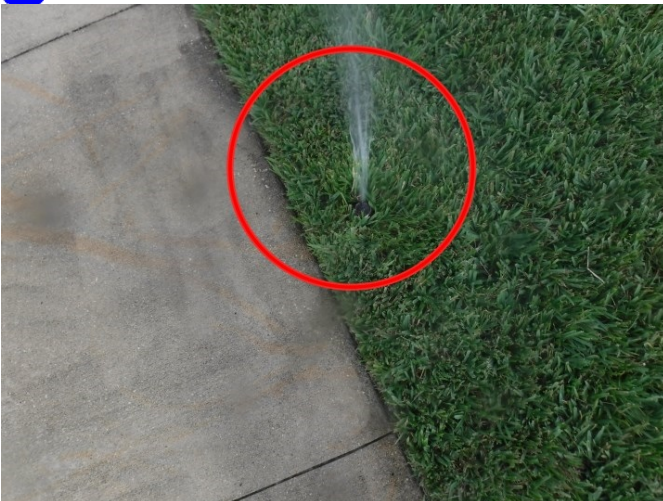
1113. SPRINKLER

You will need to add one inch extensions to your turf heads by next summer for optimum performance.

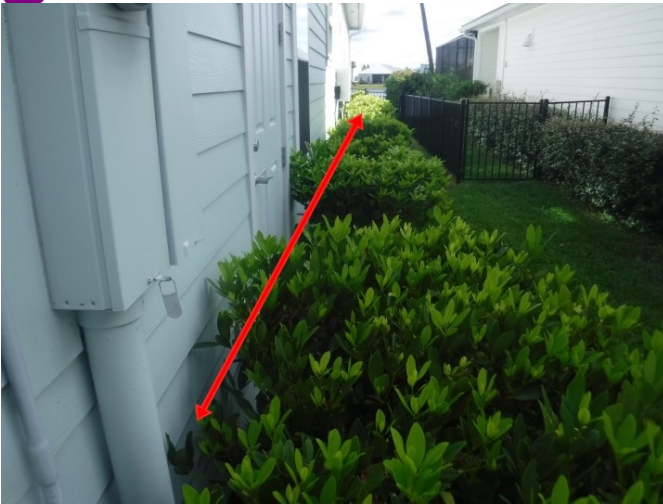
1118. EXTERIOR COMMENTS

MIN Trim back vegetation.

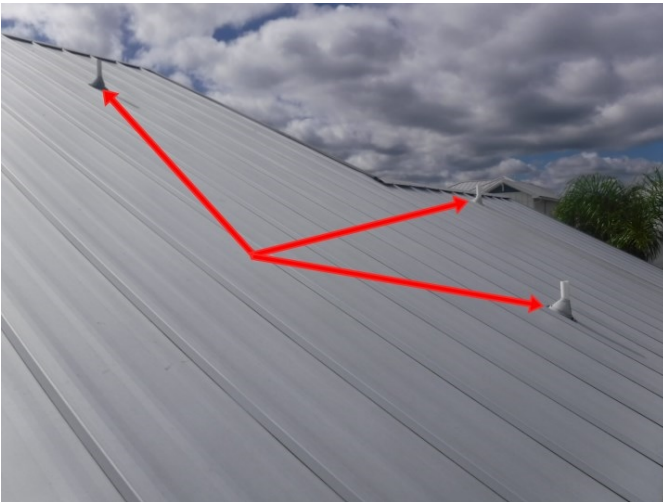
1203. EXPOSED FLASHINGS

IC Rubber drain and waste vent stack flashings do not last as long as roof materials. When the rubber grommets decay/deteriorate it often leads to minor roof leaks in those areas. Plan accordingly.

IC 16: Rubber drain and waste vent stack flashings do not last as long as roof materials. When the rubber grommets decay/deteriorate it often leads to minor roof leaks in those areas. Plan accordingly.

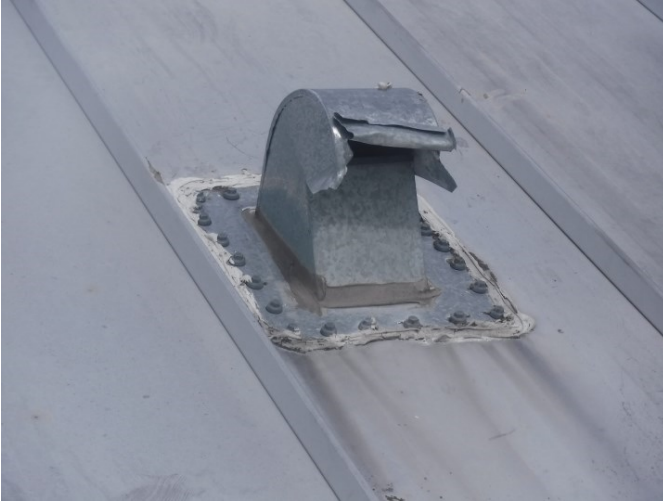
1206. ROOF COMMENTS

MIN The dryer vent is bent and has been modified from its original configuration. Reason not known. A roofer should install a correct dryer vent with back draft damper and no screen.

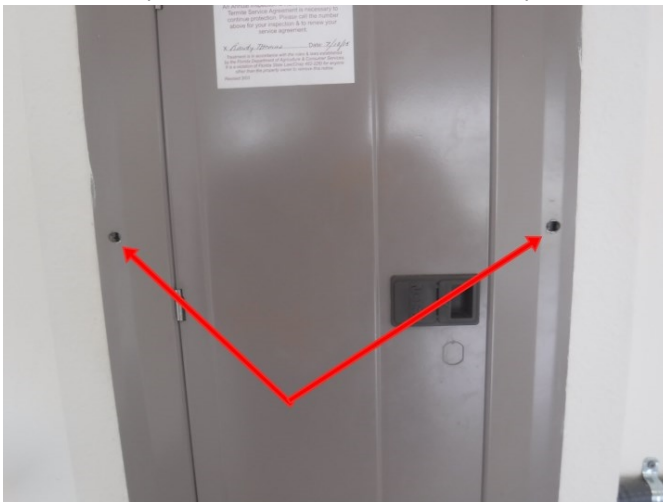
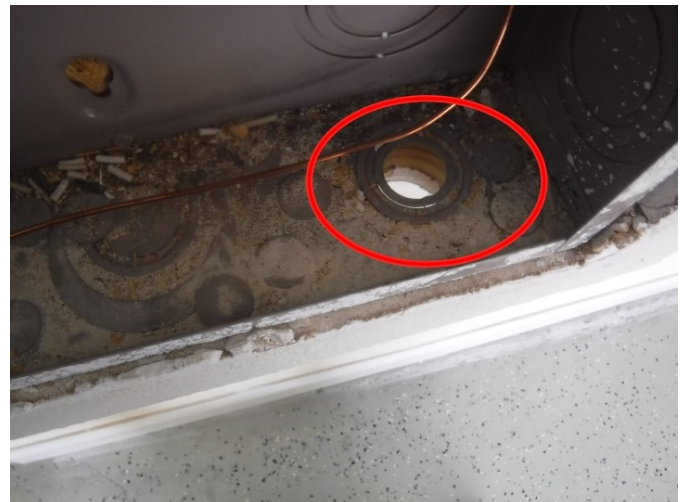
1807. ELECTRICAL COMMENTS

MIN There are two fasteners missing at main distribution center/panel. Recommend installing.

There is an open knock out at the bottom of the panel that should be filled with a blank/cover. Correct as needed.

MIN 7: There are two fasteners missing at main distribution center/panel. Recommend installing.

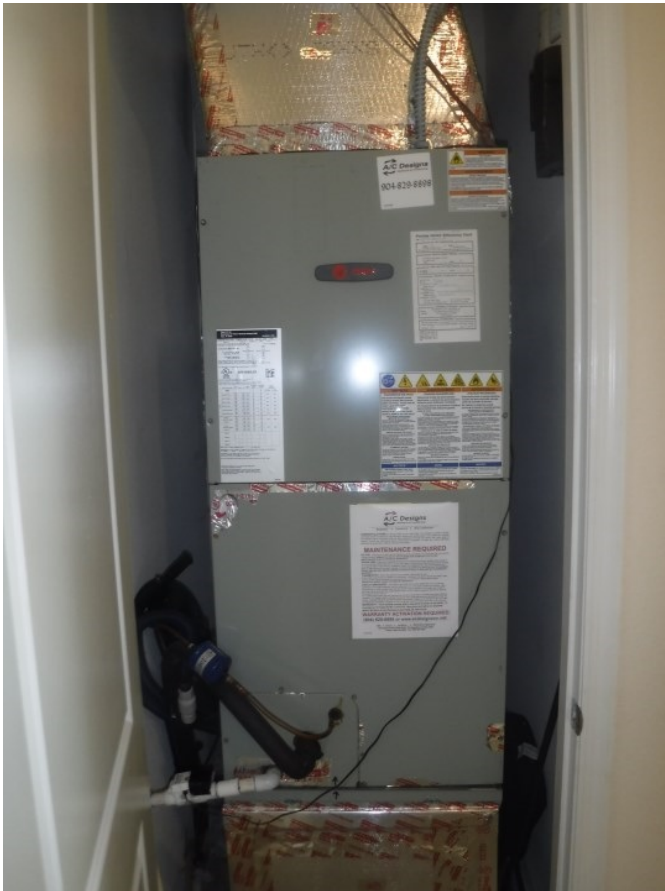
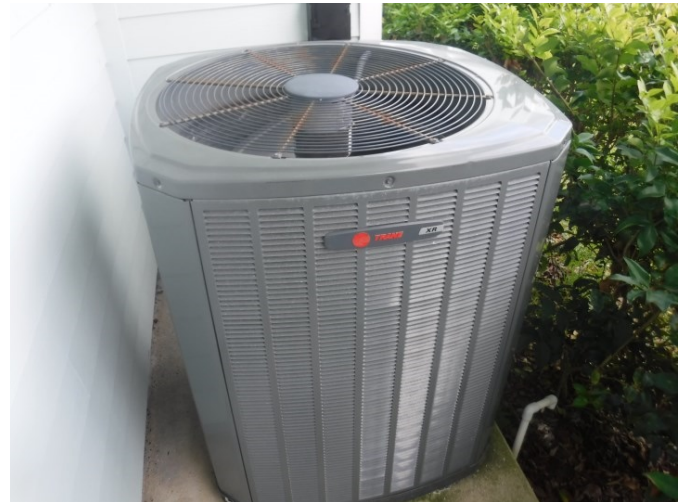
2001. LOCATION OF UNIT

Air handler is located at interior closet.

Condensing unit is located at the rear.

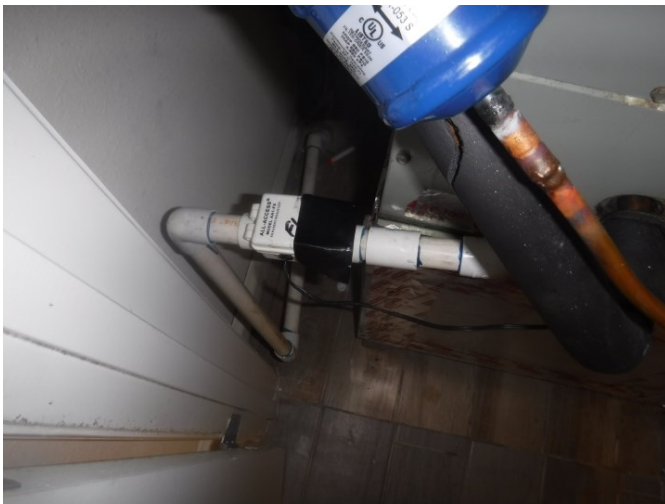
2010. AIR CONDITIONING COMMENTS

The air handler(s) in this home are equipped with condensation overflow shutoff switch. These devices sense/detect a rising column of condensation in the discharge line and send a signal to the air handler to turn off in the event of a potential condensation overflow.

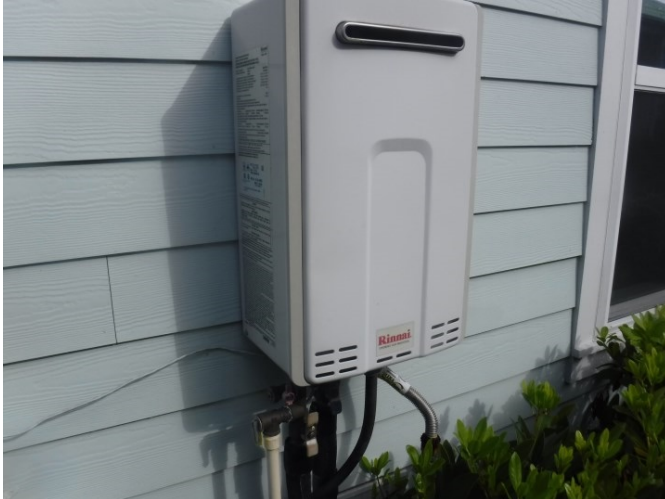
2101. LOCATION OF UNIT

The water heater is located in the right side.

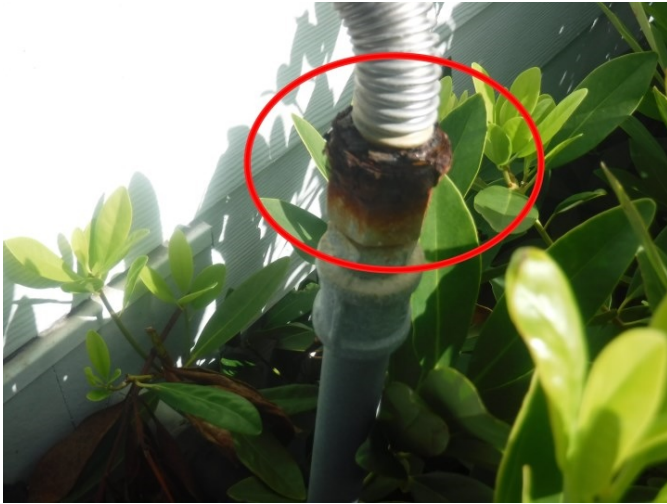
2108. WATER HEATER CONDITION

MIN Heavy corrosion at gas connector observed, this is a potential safety concern. Suggest replacing with an approved flexible connector for safety.

MIN 8: Heavy corrosion at gas connector observed, this is a potential safety concern. Suggest replacing with an approved flexible connector for safety.

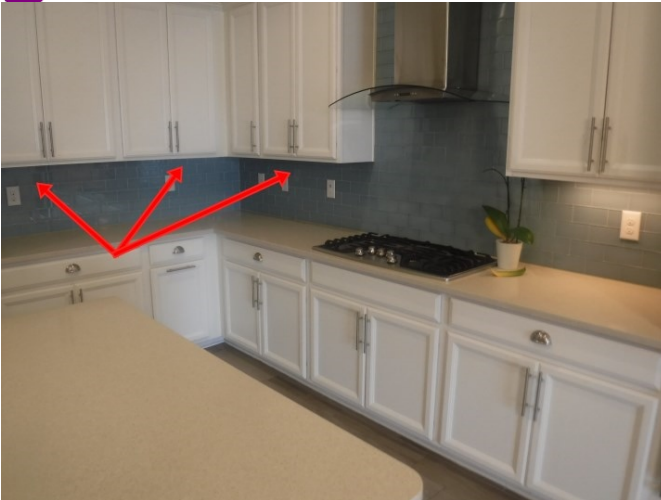
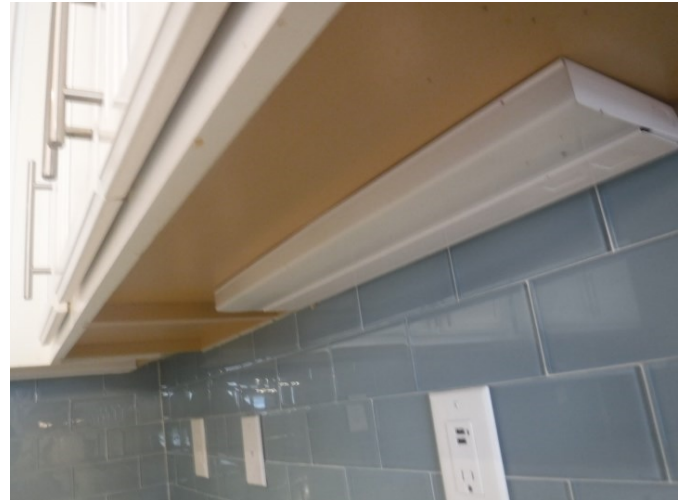
2222. KITCHEN COMMENTS

MIN There are three under cabinet lights that were not working. Repair as needed.

MIN 9: There are three under cabinet lights that were not working. Repair as needed.

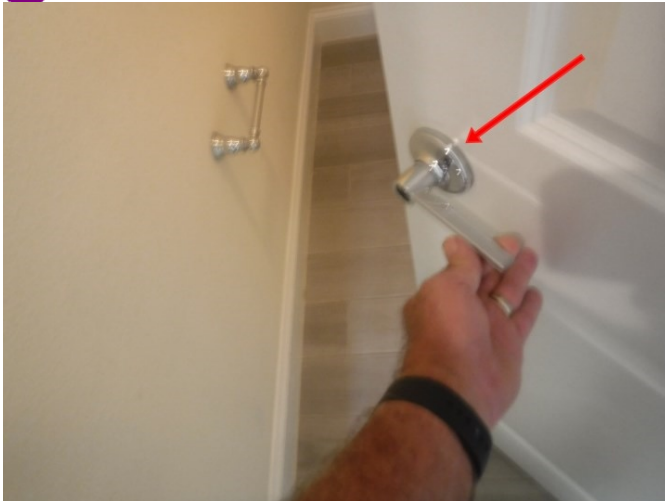
2305. DOORS

MIN Hardware is loose at door to water closet. Recommend review for repair or replacement as necessary.

MIN 10: Hardware is loose at door to water closet. Recommend review for repair or replacement as necessary.

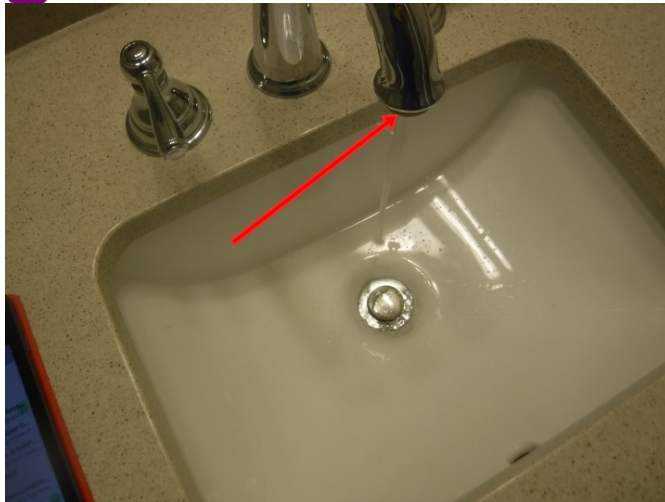
2319. SINKS

MIN Clean aerator at sink faucet for better performance

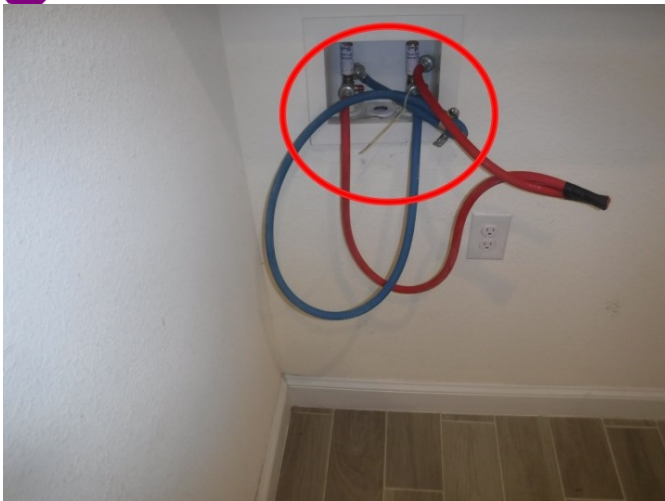
2512. WASHER HOOKUPS

MIN Hoses are still connected. This often indicates the shutoffs are dripping/leaking. A plumber should correct.

MIN 12: Hoses are still connected. This often indicates the shutoffs are dripping/leaking. A plumber should correct.

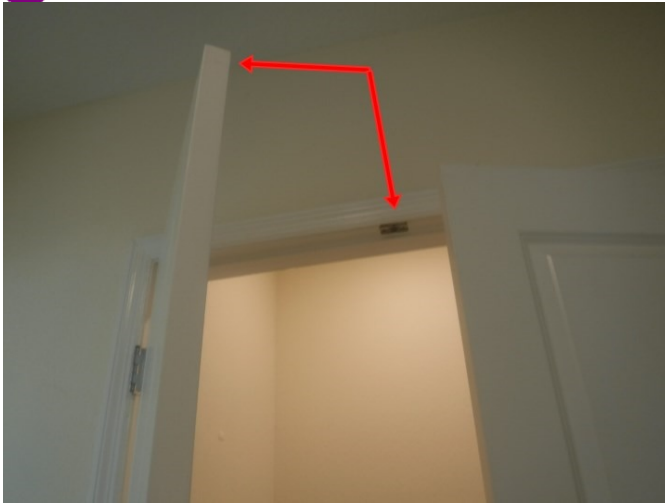
2604. DOORS

MIN Hardware is damaged (ball and spring) at hall closet door. Recommend review for repair or replacement as necessary.

MIN 13: Hardware is damaged (ball and spring) at hall closet door. Recommend review for repair or replacement as necessary.

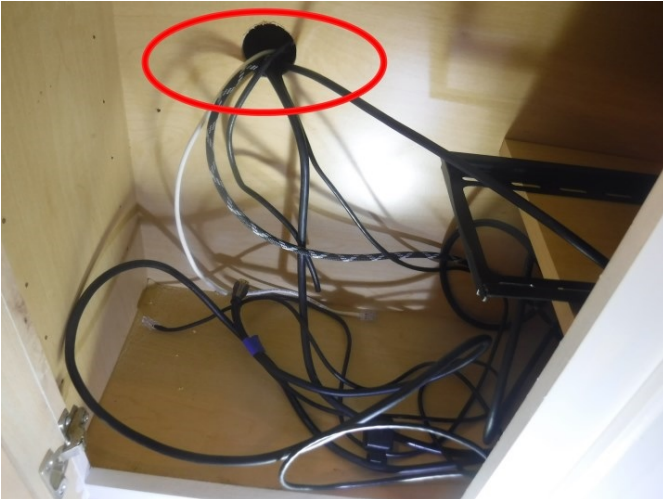
2638. LIVING ROOM COMMENTS

IC There is a post construction wall unit here. The wall receptacle is now covered with cabinets. Power is provided via a strip center and or extension cord rather than directly to receptacle.

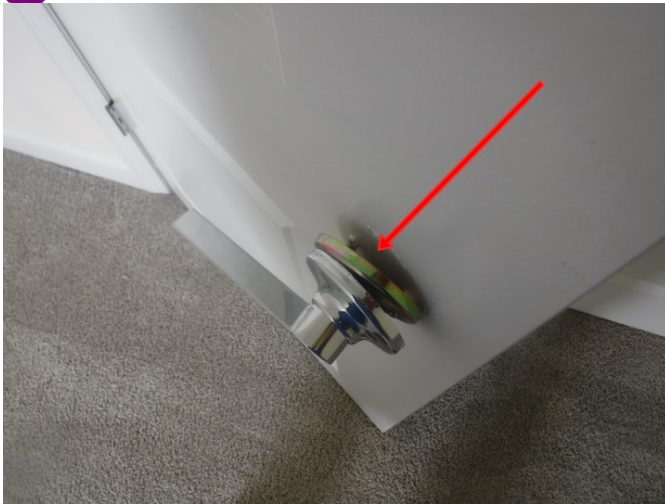
2585. CLOSET/WARDROBE

MIN Hardware is damaged/loose left side bedroom, replacement/repairs are needed for proper operation.

MIN 14: Hardware is damaged/loose left side bedroom, replacement/repairs are needed for proper operation.
