# Confidential Inspection Report

[REDACTED]  
St. Augustine, FL 32092

Inspector, Charles Gifford FLHI 1046 FLCRC 1326414  
AllSpec Services

Monday, September 16, 2024

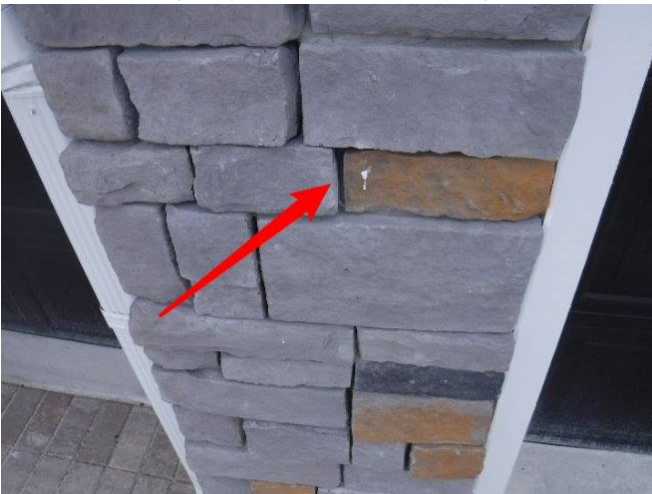
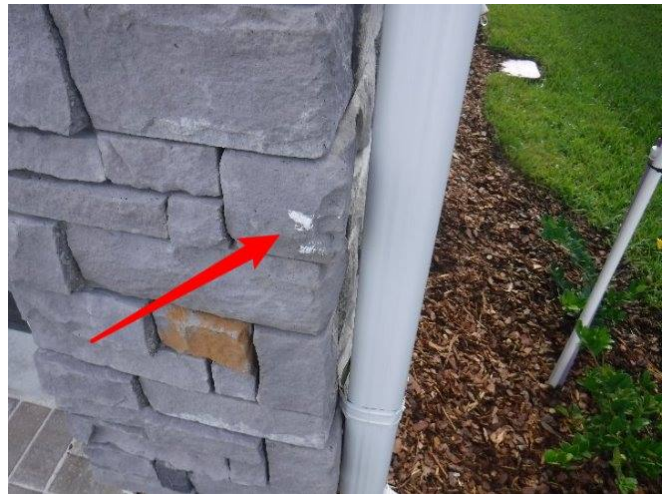
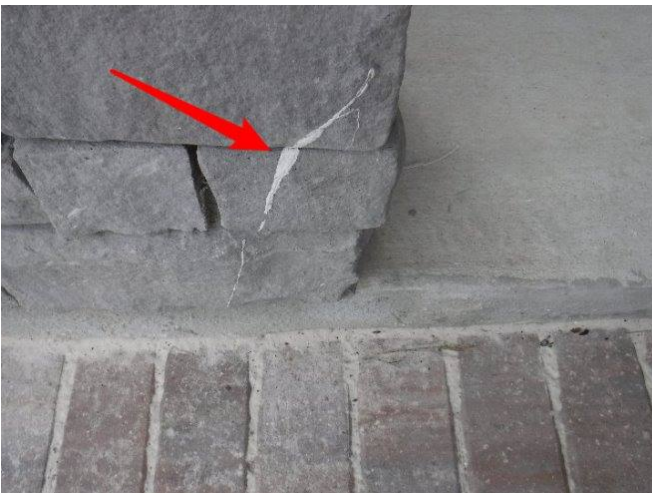
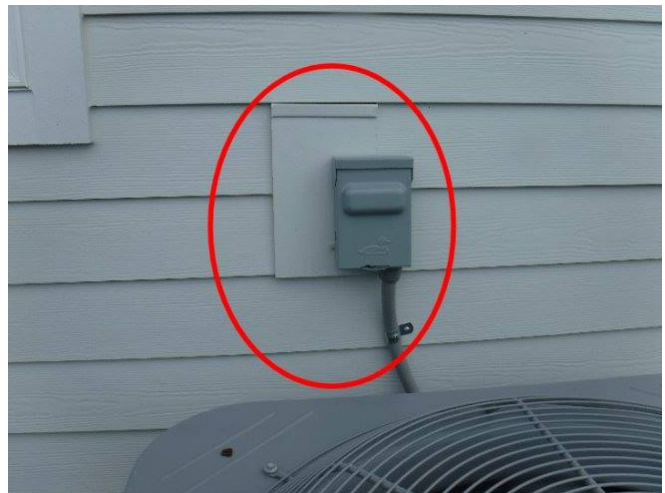
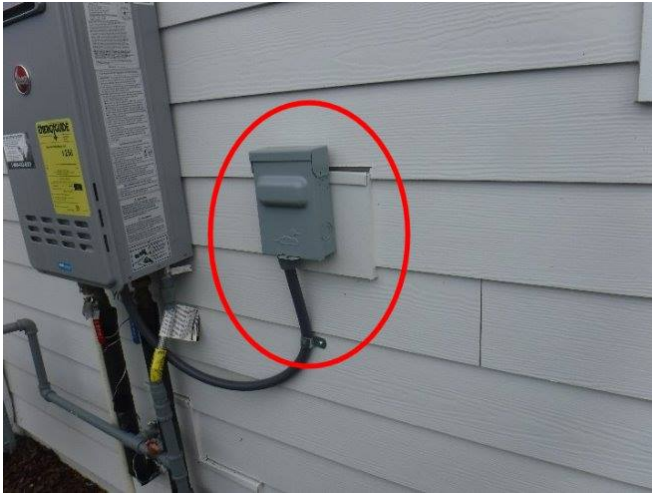
**BPL** White paint on stone several areas.  
Disconnects are poorly centered at condensing unit and at water heater.

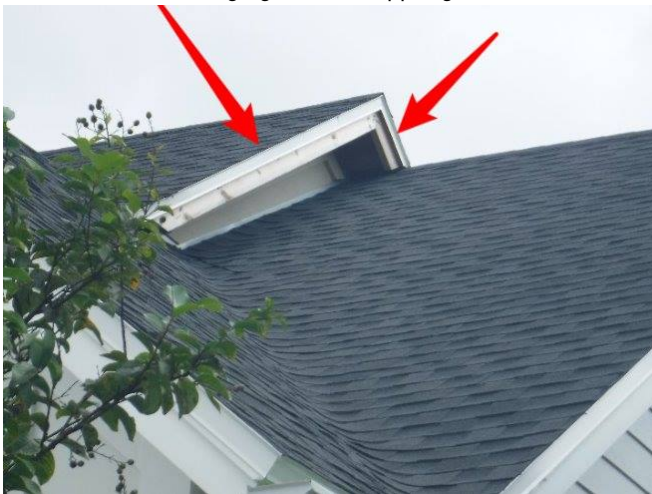
**BPL** This home has metal a metal fascia and vinyl soffits. It is not possible to inspect those areas that are covered.

Fascia/soffit is missing right side at upper gable.

**BPL 3:** This home has metal a metal fascia and vinyl soffits. It is not possible to inspect those areas that are covered.  
Fascia/soffit is missing right side at upper gable.

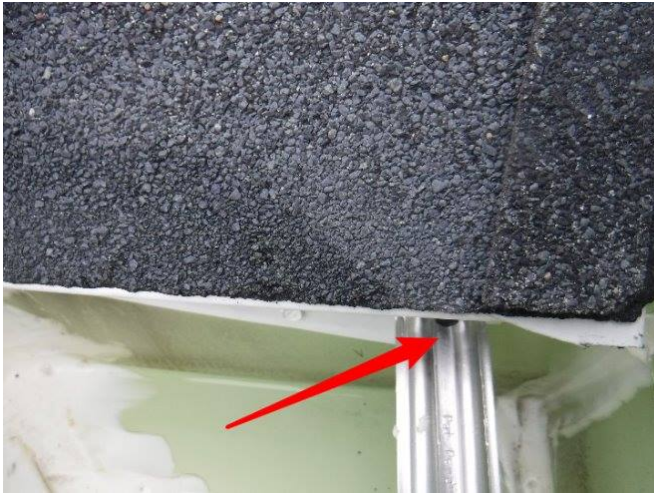
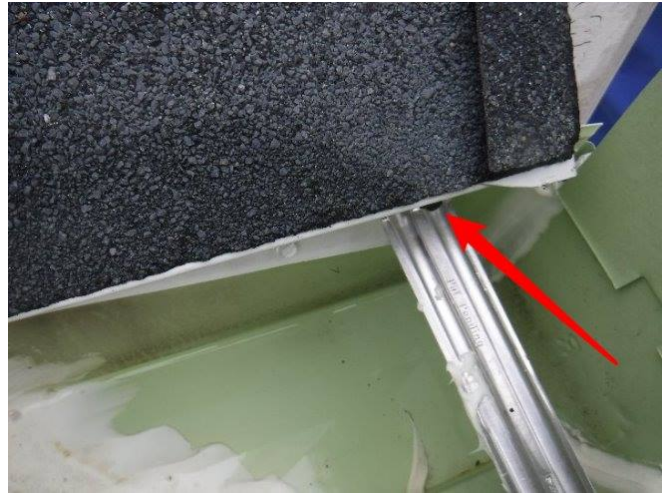
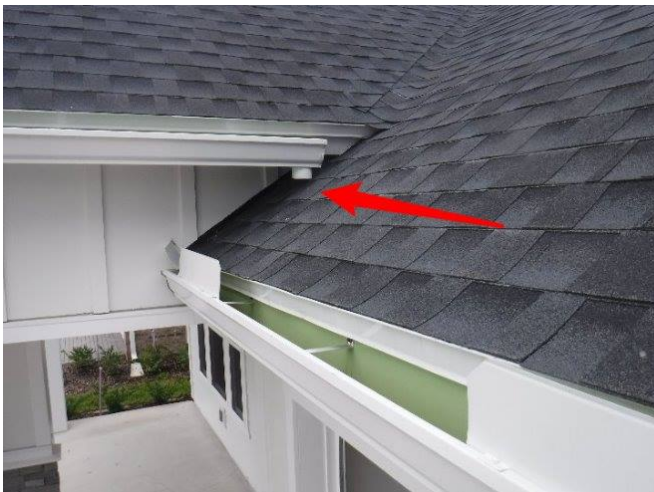
Hidden fastener has been attached through eaves drip edge between entry and garage. This is a poor practice. Eaves drip/drip edge should remain intact. An upper level gutter drains to roof below. A small downspout should be used to carry water to lower level gutter.

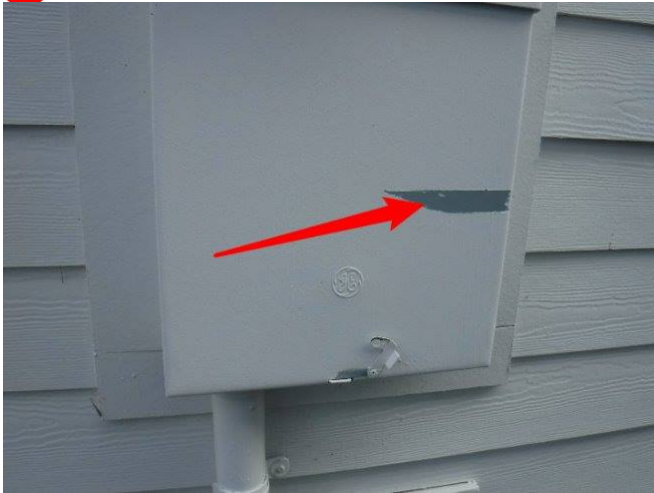
**BPL** Raw metal at dead front cover.

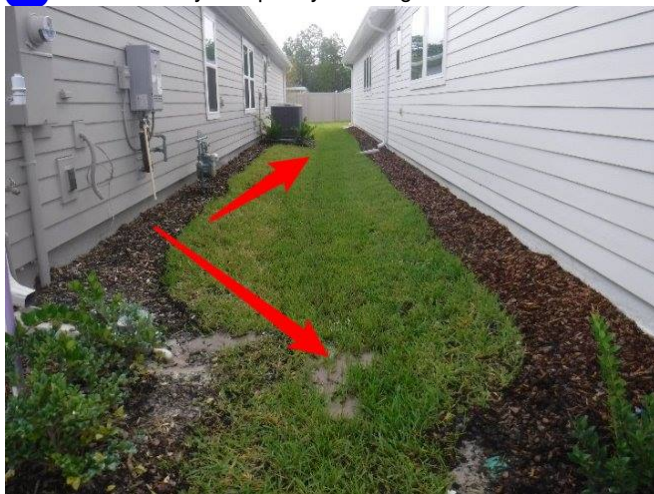
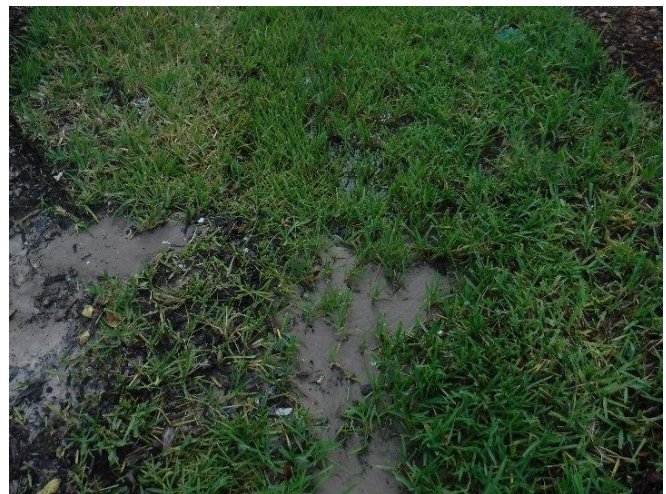
**IC** Recent heavy rain.poorly draining left side.

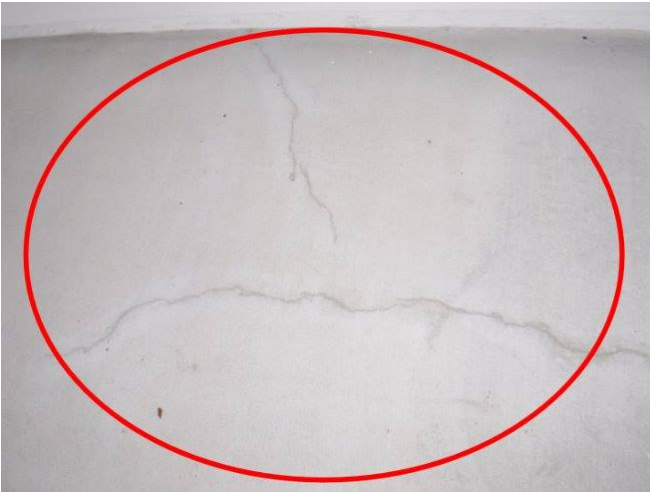
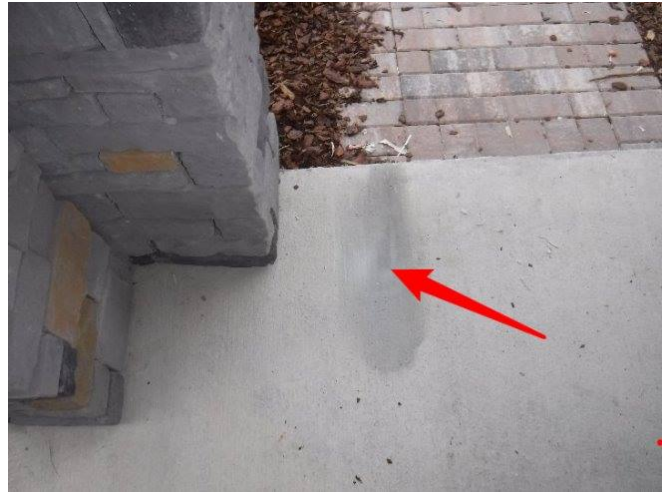
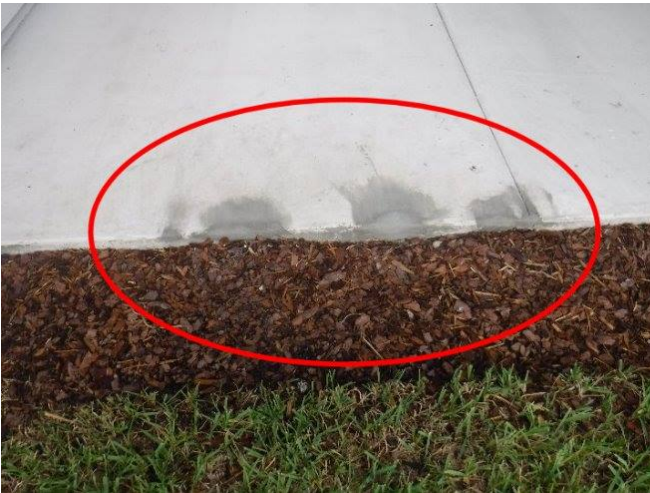
**BPL** Common cracks observed. This is a typical condition caused when the concrete moves from the wet to dry state. These cracks are commonly referred to as shrinkage cracks.

Patching observed. Front porch and rear lanai.

**BPL 7:** Common cracks observed. This is a typical condition caused when the concrete moves from the wet to dry state. These cracks are commonly referred to as shrinkage cracks.

As the front porch and rear lanai are important features to the home you may want the builder to apply a finish to mask the cracks and cover the patches.

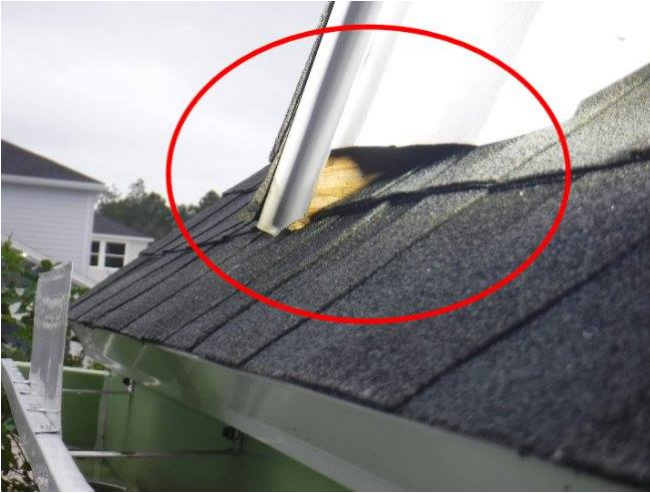
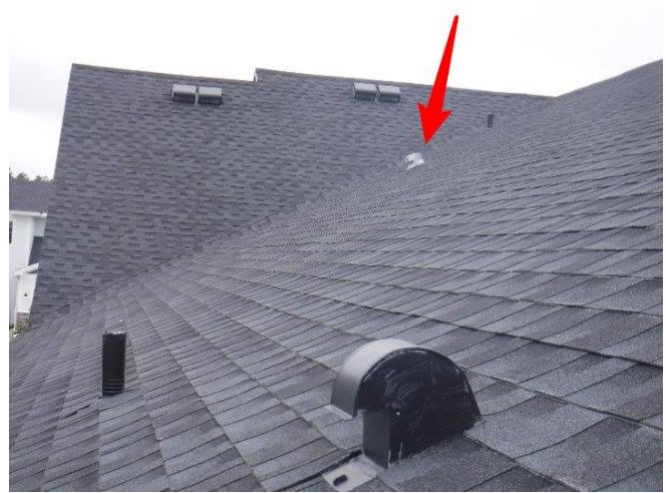
**BPL** Poor cut at fascia, right front. Visible roof decking and large opening. Correct as needed.  
Raw metal, dryer vent. Recommend painting.

**BPL 8:** Poor cut at fascia, right front. Visible roof decking and large opening. Correct as needed.  
Raw metal, dryer vent. Recommend painting.

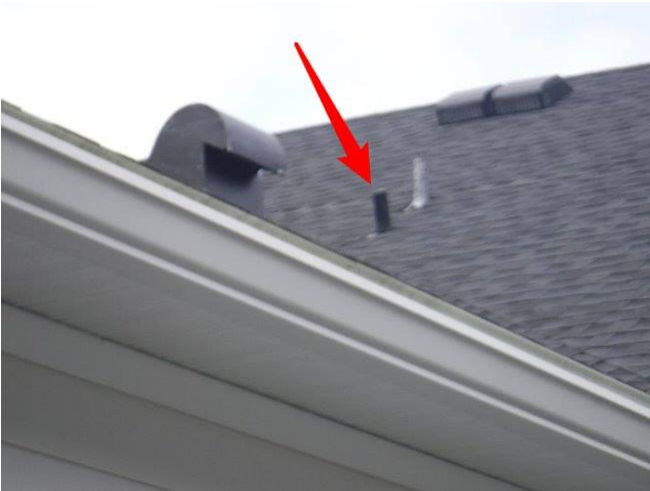
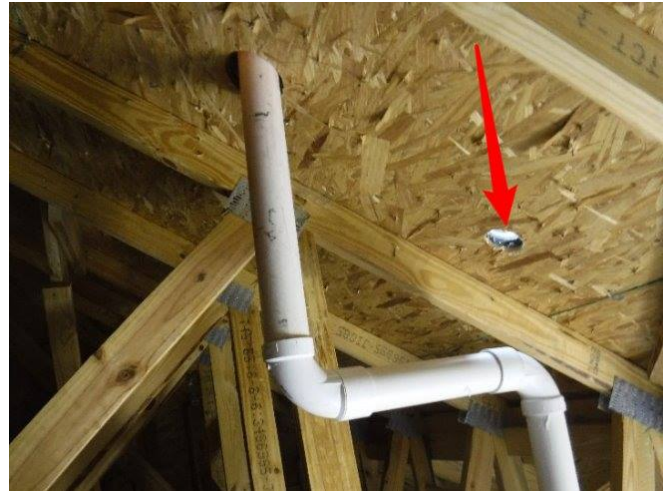
The lower left side waste vent stack flashing is not filled with pipe. This is soft lead flashing and is serving no purpose. The builder should fill hole, remove this flashing and repair roof this location.

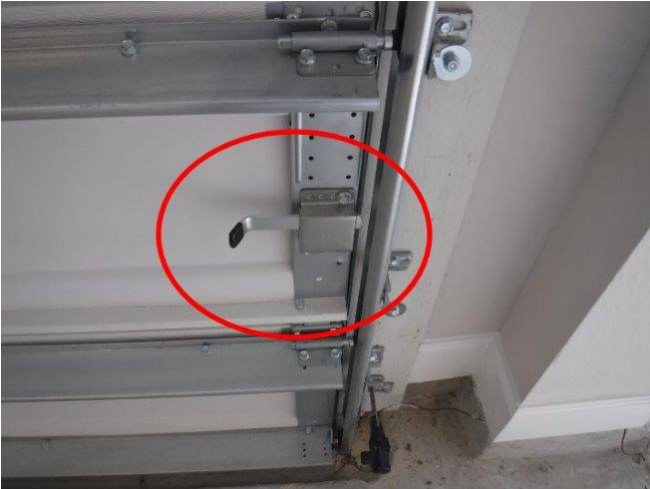
**BPL** The garage door lock was not disabled. When a garage door opener is installed, the mechanical door lock should be disabled to prevent damage to the door if the opener should be activated when the lock is engaged.

**BPL 9:** The garage door lock was not disabled. When a garage door opener is installed, the mechanical door lock should be disabled to prevent damage to the door if the opener should be activated when the lock is engaged.

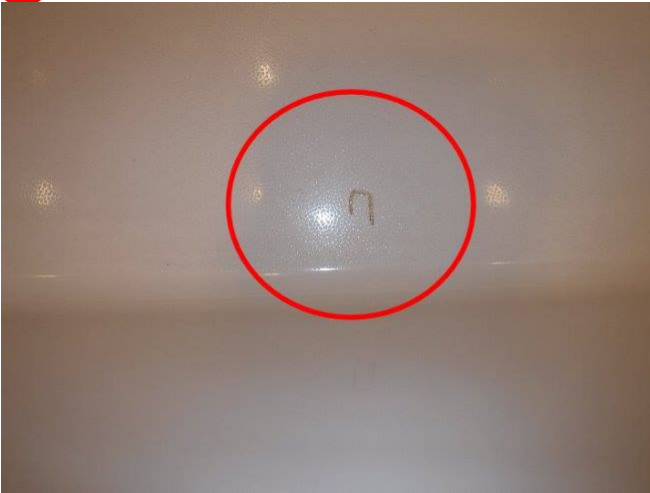
**BPL** Rust stain.

**BPL** 16: Rust stain.

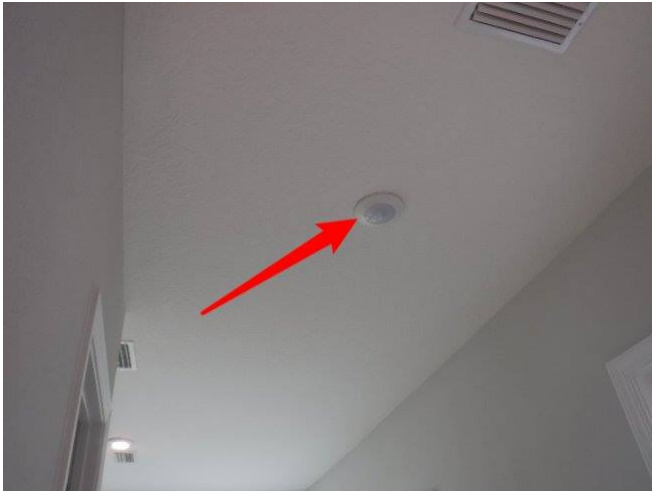
**BPL** 3-way switch is inoperable or improperly connected at left rear small hallway, recommend review for repair is needed for proper operation.

**BPL** 19: 3-way switch is inoperable or improperly connected at left rear small hallway, recommend review for repair is needed for proper operation.

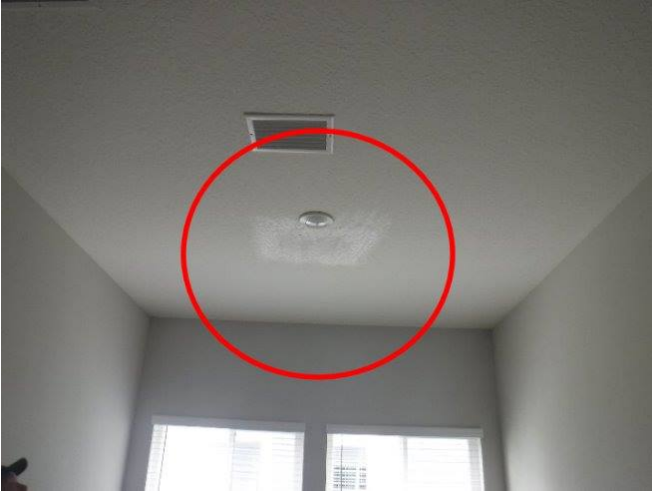
**BPL** Readily visible repair. Repaint ceiling to mask.

**BPL** 21: Readily visible repair. Repaint ceiling to mask.

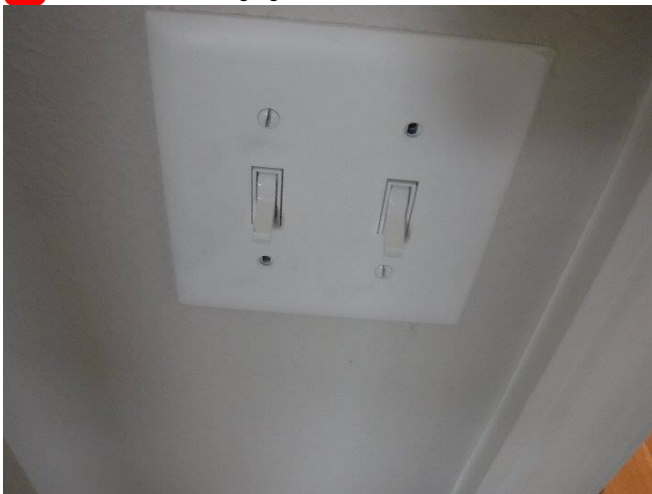
**BPL** Fasteners missing light switch left front bedroom.

**BPL** 22: Fasteners missing light switch left front bedroom.
